# How to identify affected extinguishers!

Tyco has been made aware of an extremely small number of incidents where stress corrosion cracking appears to have caused the valve to fail. This has resulted in the valve being released unexpectedly. Tyco has learned that these valves, purchased by Tyco from a supplier, did not meet the supplier's specifications.

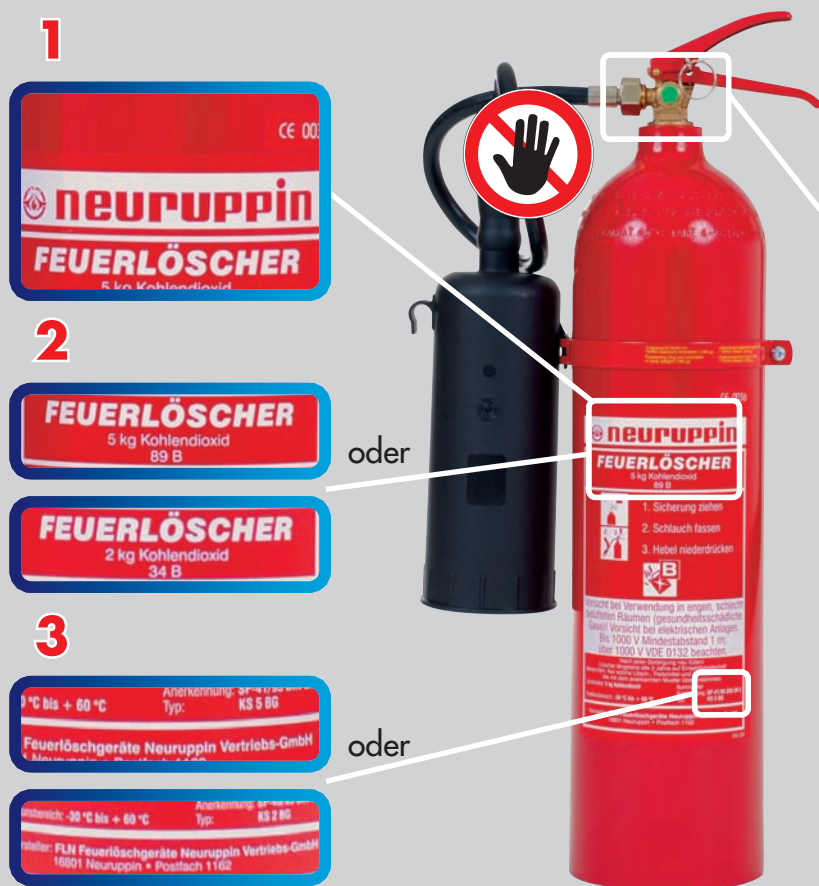
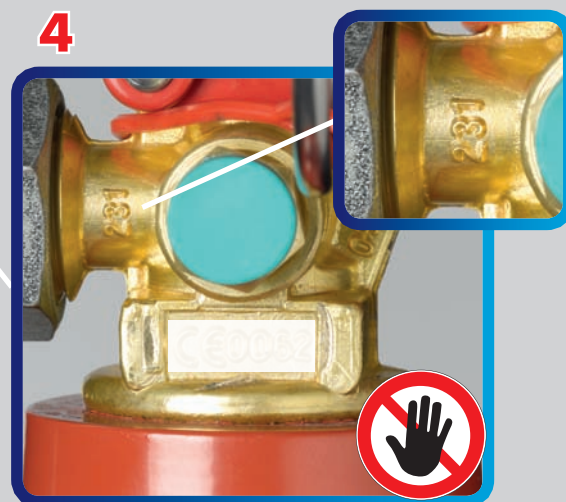
## Affected: 4 POINTS TO IDENTIFY ...

The valve looks the same on 2 kg and on 5 kg extinguishers. On the left hand side of the valve, next to the extinguisher's pipe, you will see the number 231.

**The screw thread cannot be seen.**

**The screw thread can not be seen.**

**DO NOT MOVE OR TOUCH THE FIRE EXTINGUISHER!**

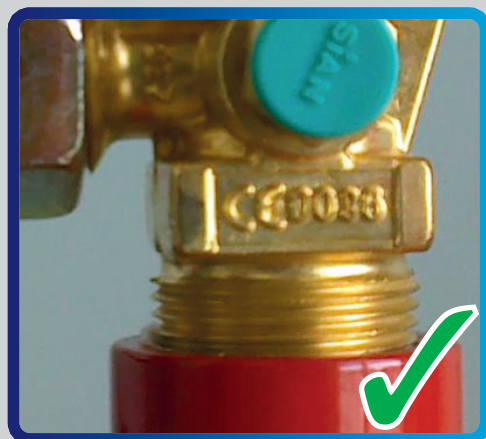
## Not affected:

**Not affected are neuruppin extinguisher types if the screw thread is visible.**
